丸木鉄線による柵 立面図

万年堀下部残し図

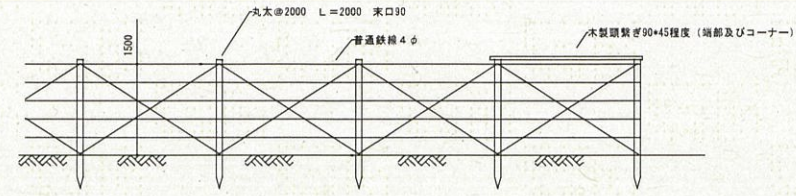
縮尺  
A1-1/50  
A3-1/100

丸太鉄線による柵 既設万年礫 (下部残し) (万年礫下部残し図参照)
